**COMPREHENSIVE NEEDS ASSESSMENT FOR  
CHINOOK SALMON HABITAT IMPROVEMENT PROJECTS  
IN THE SAN JOAQUIN RIVER BASIN**

March 1994

Prepared for the California Department of Fish and Game  
by the  
California Department of Water Resources' San Joaquin District  
under Contract FG20841F/165038

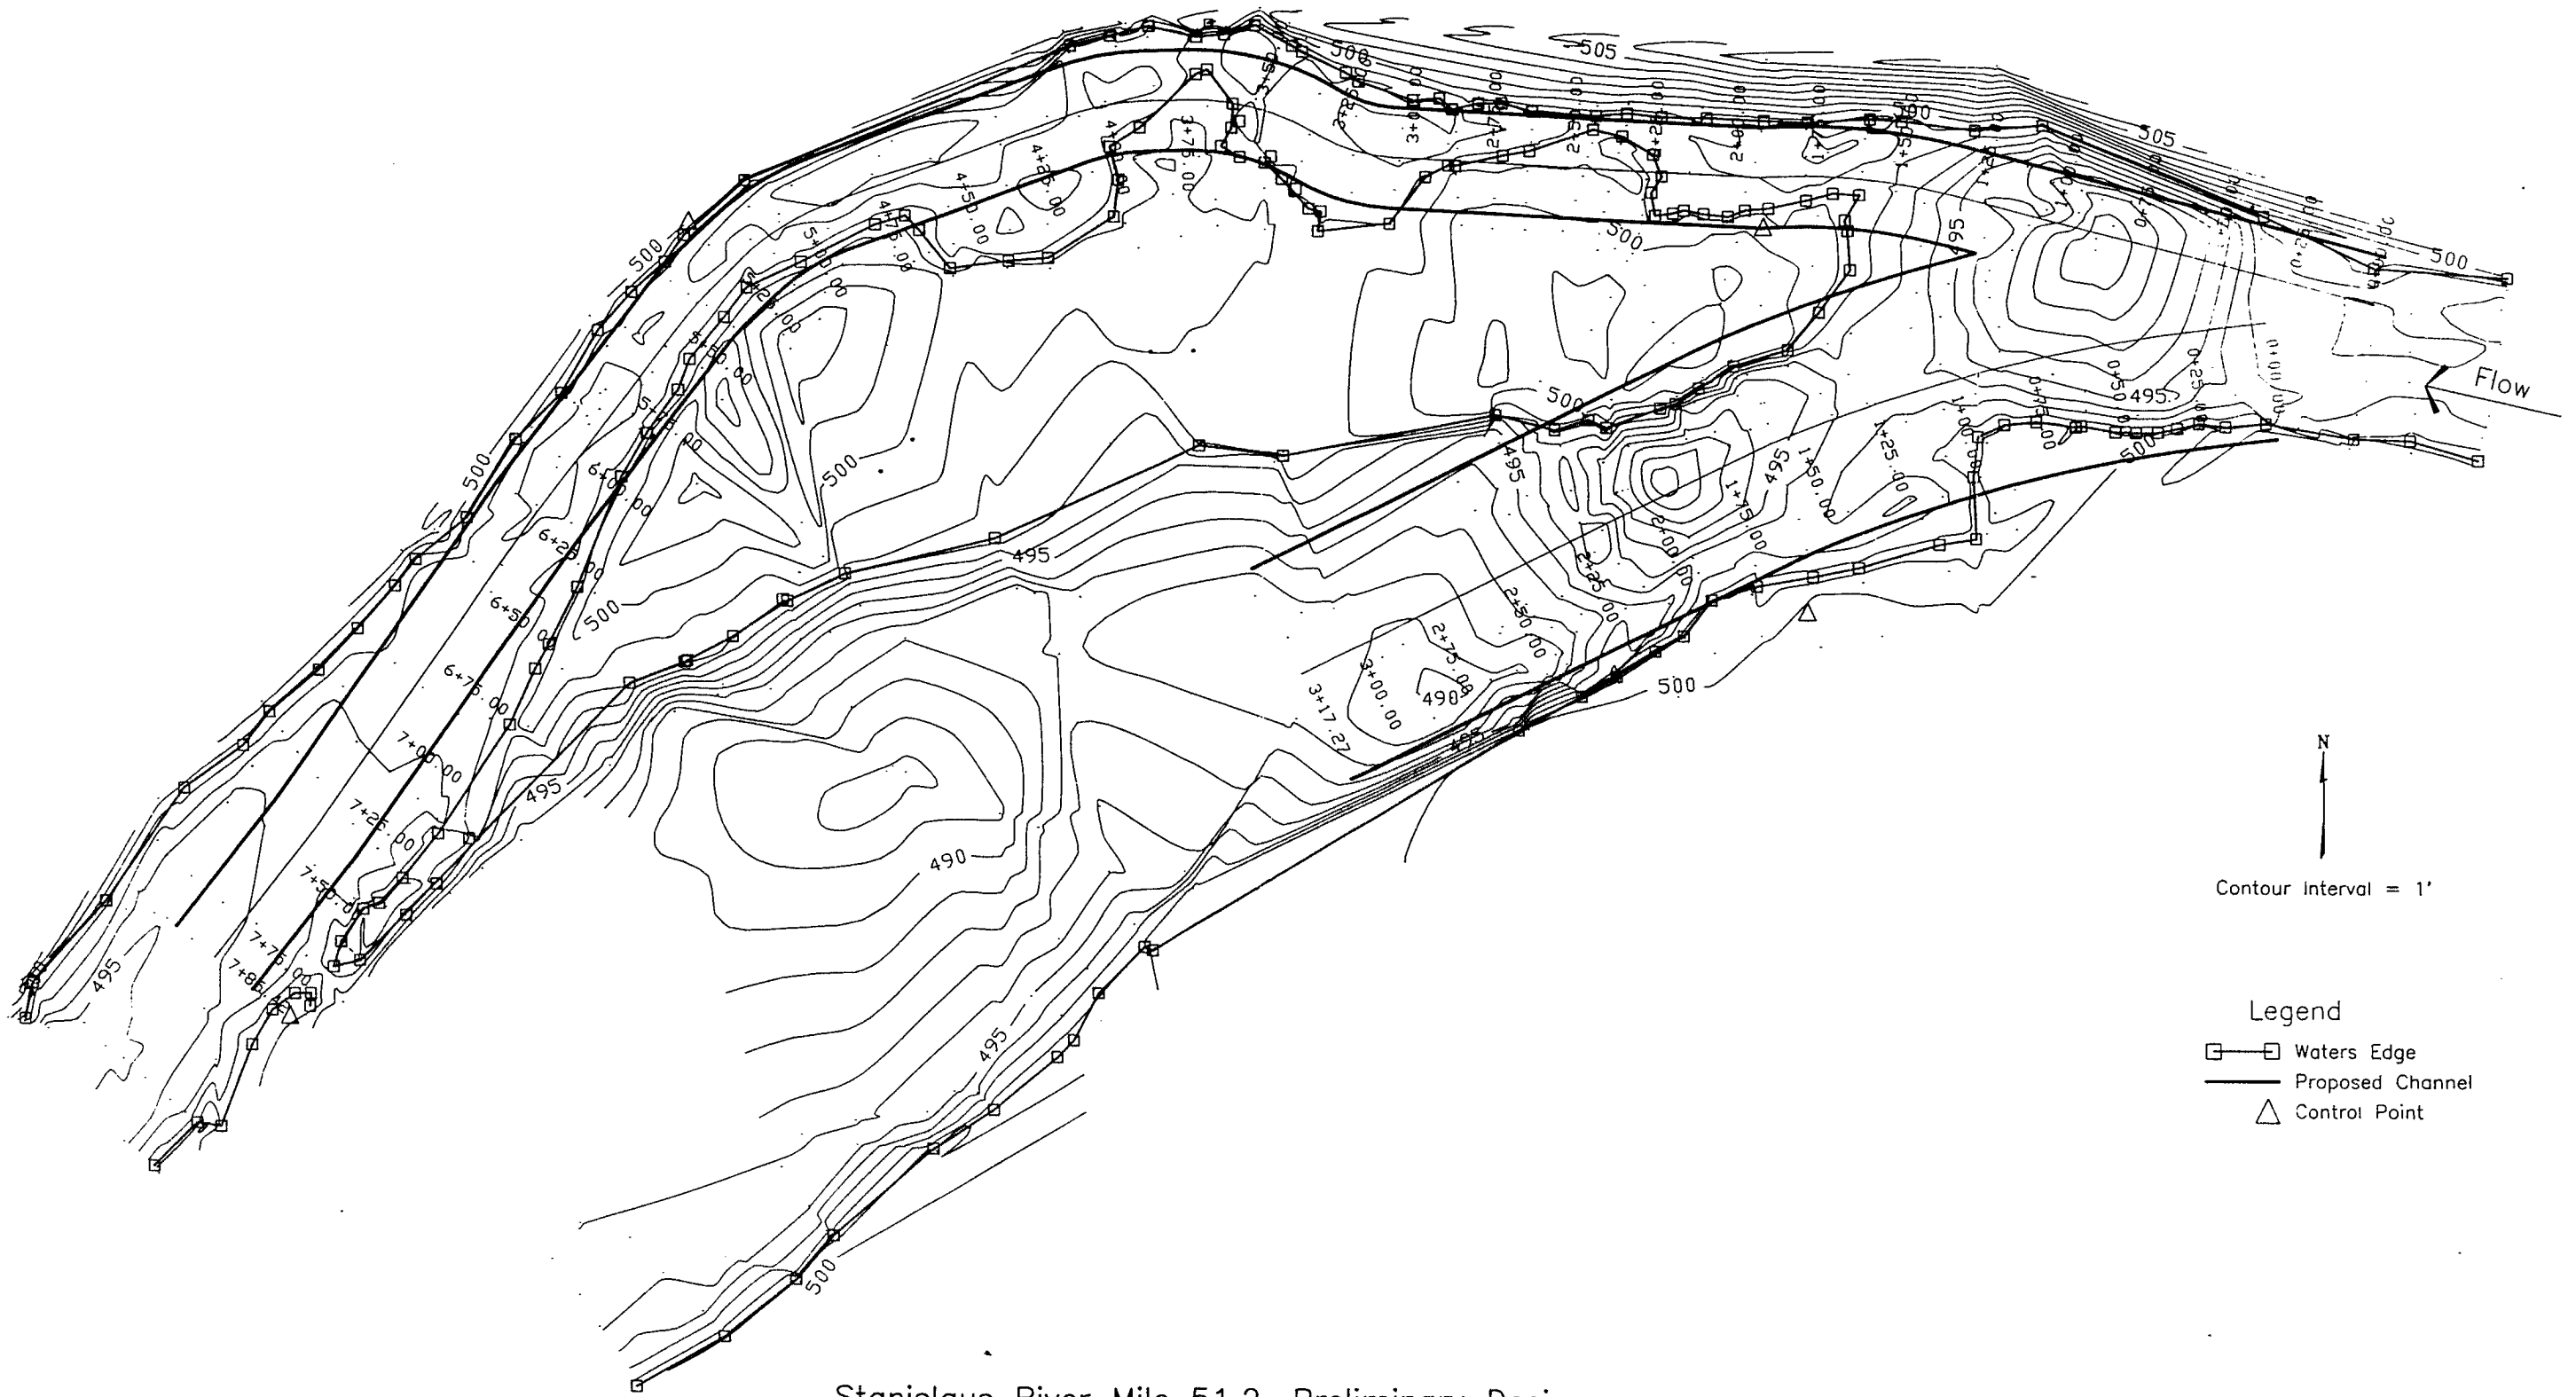
Stanislaus River Mile 51.2, Preliminary Design

Stanislaus River, Mile 51.2, Graupner.  
View toward down channel from upstream end.

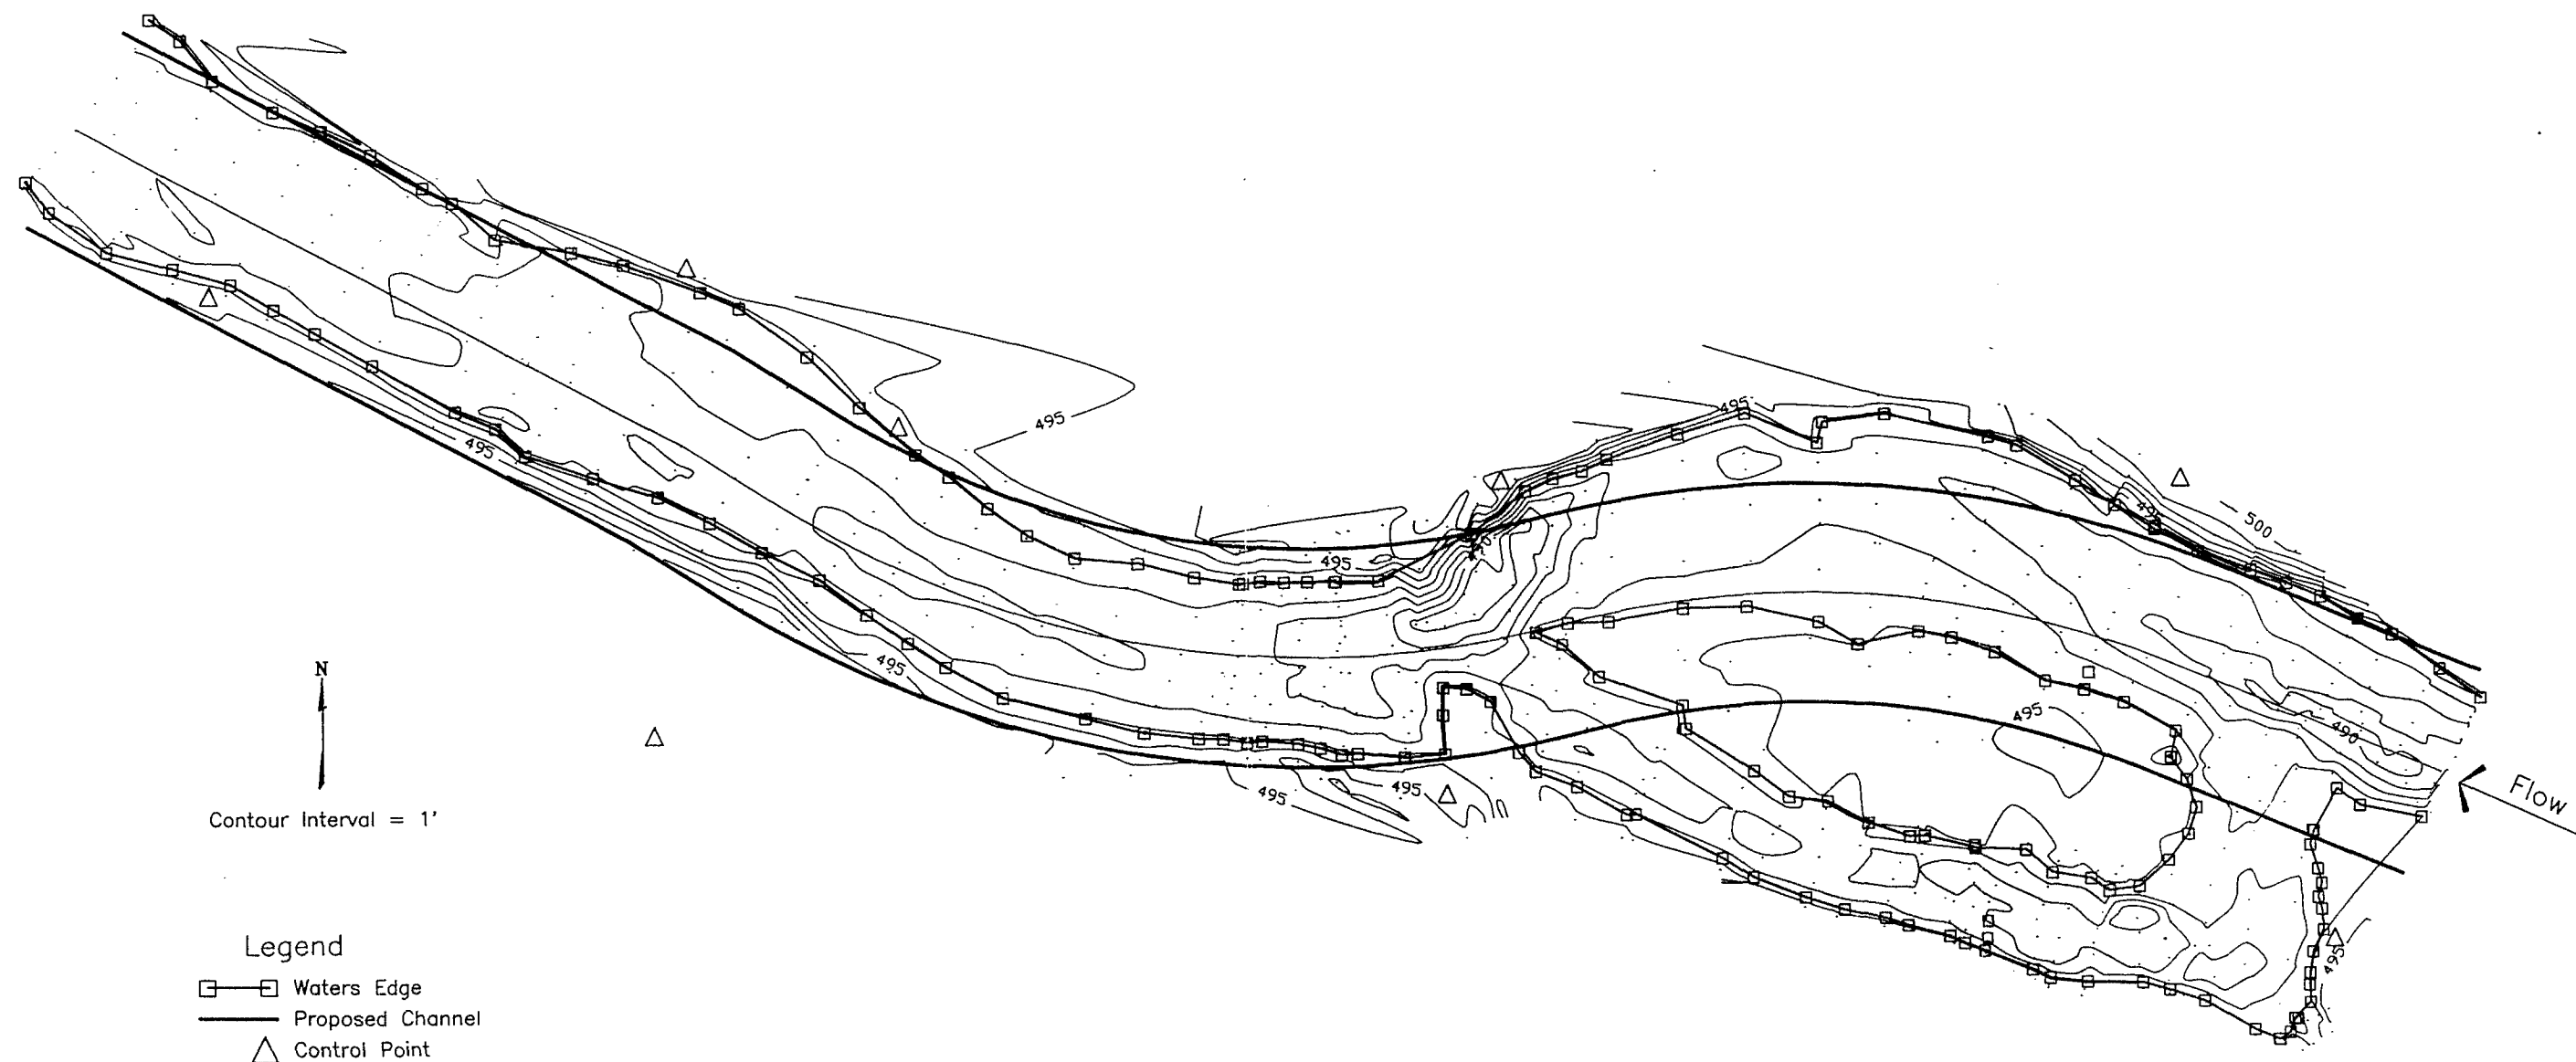
Stanislaus River Mile 48.8 & 48.9, Preliminary Design

Stanislaus River, Mile 48.9, Honolulu Bar.  
Left side channel looking upstream.

| River Mile | Site | Approximate Length or Area | Habitat Type | Site Description | Project Description | Rank (B+E)* |
|---|---|---|---|---|---|---|
| 48.5-49.7,<br>48.8-48.9** | Honolulu Bar | 5,000 feet | Spawning | Opportunity for habitat diversity, riffle, pool, run sequence. | Replace gravel. Block off south channel to increase flow in north channel. | 1+1 |

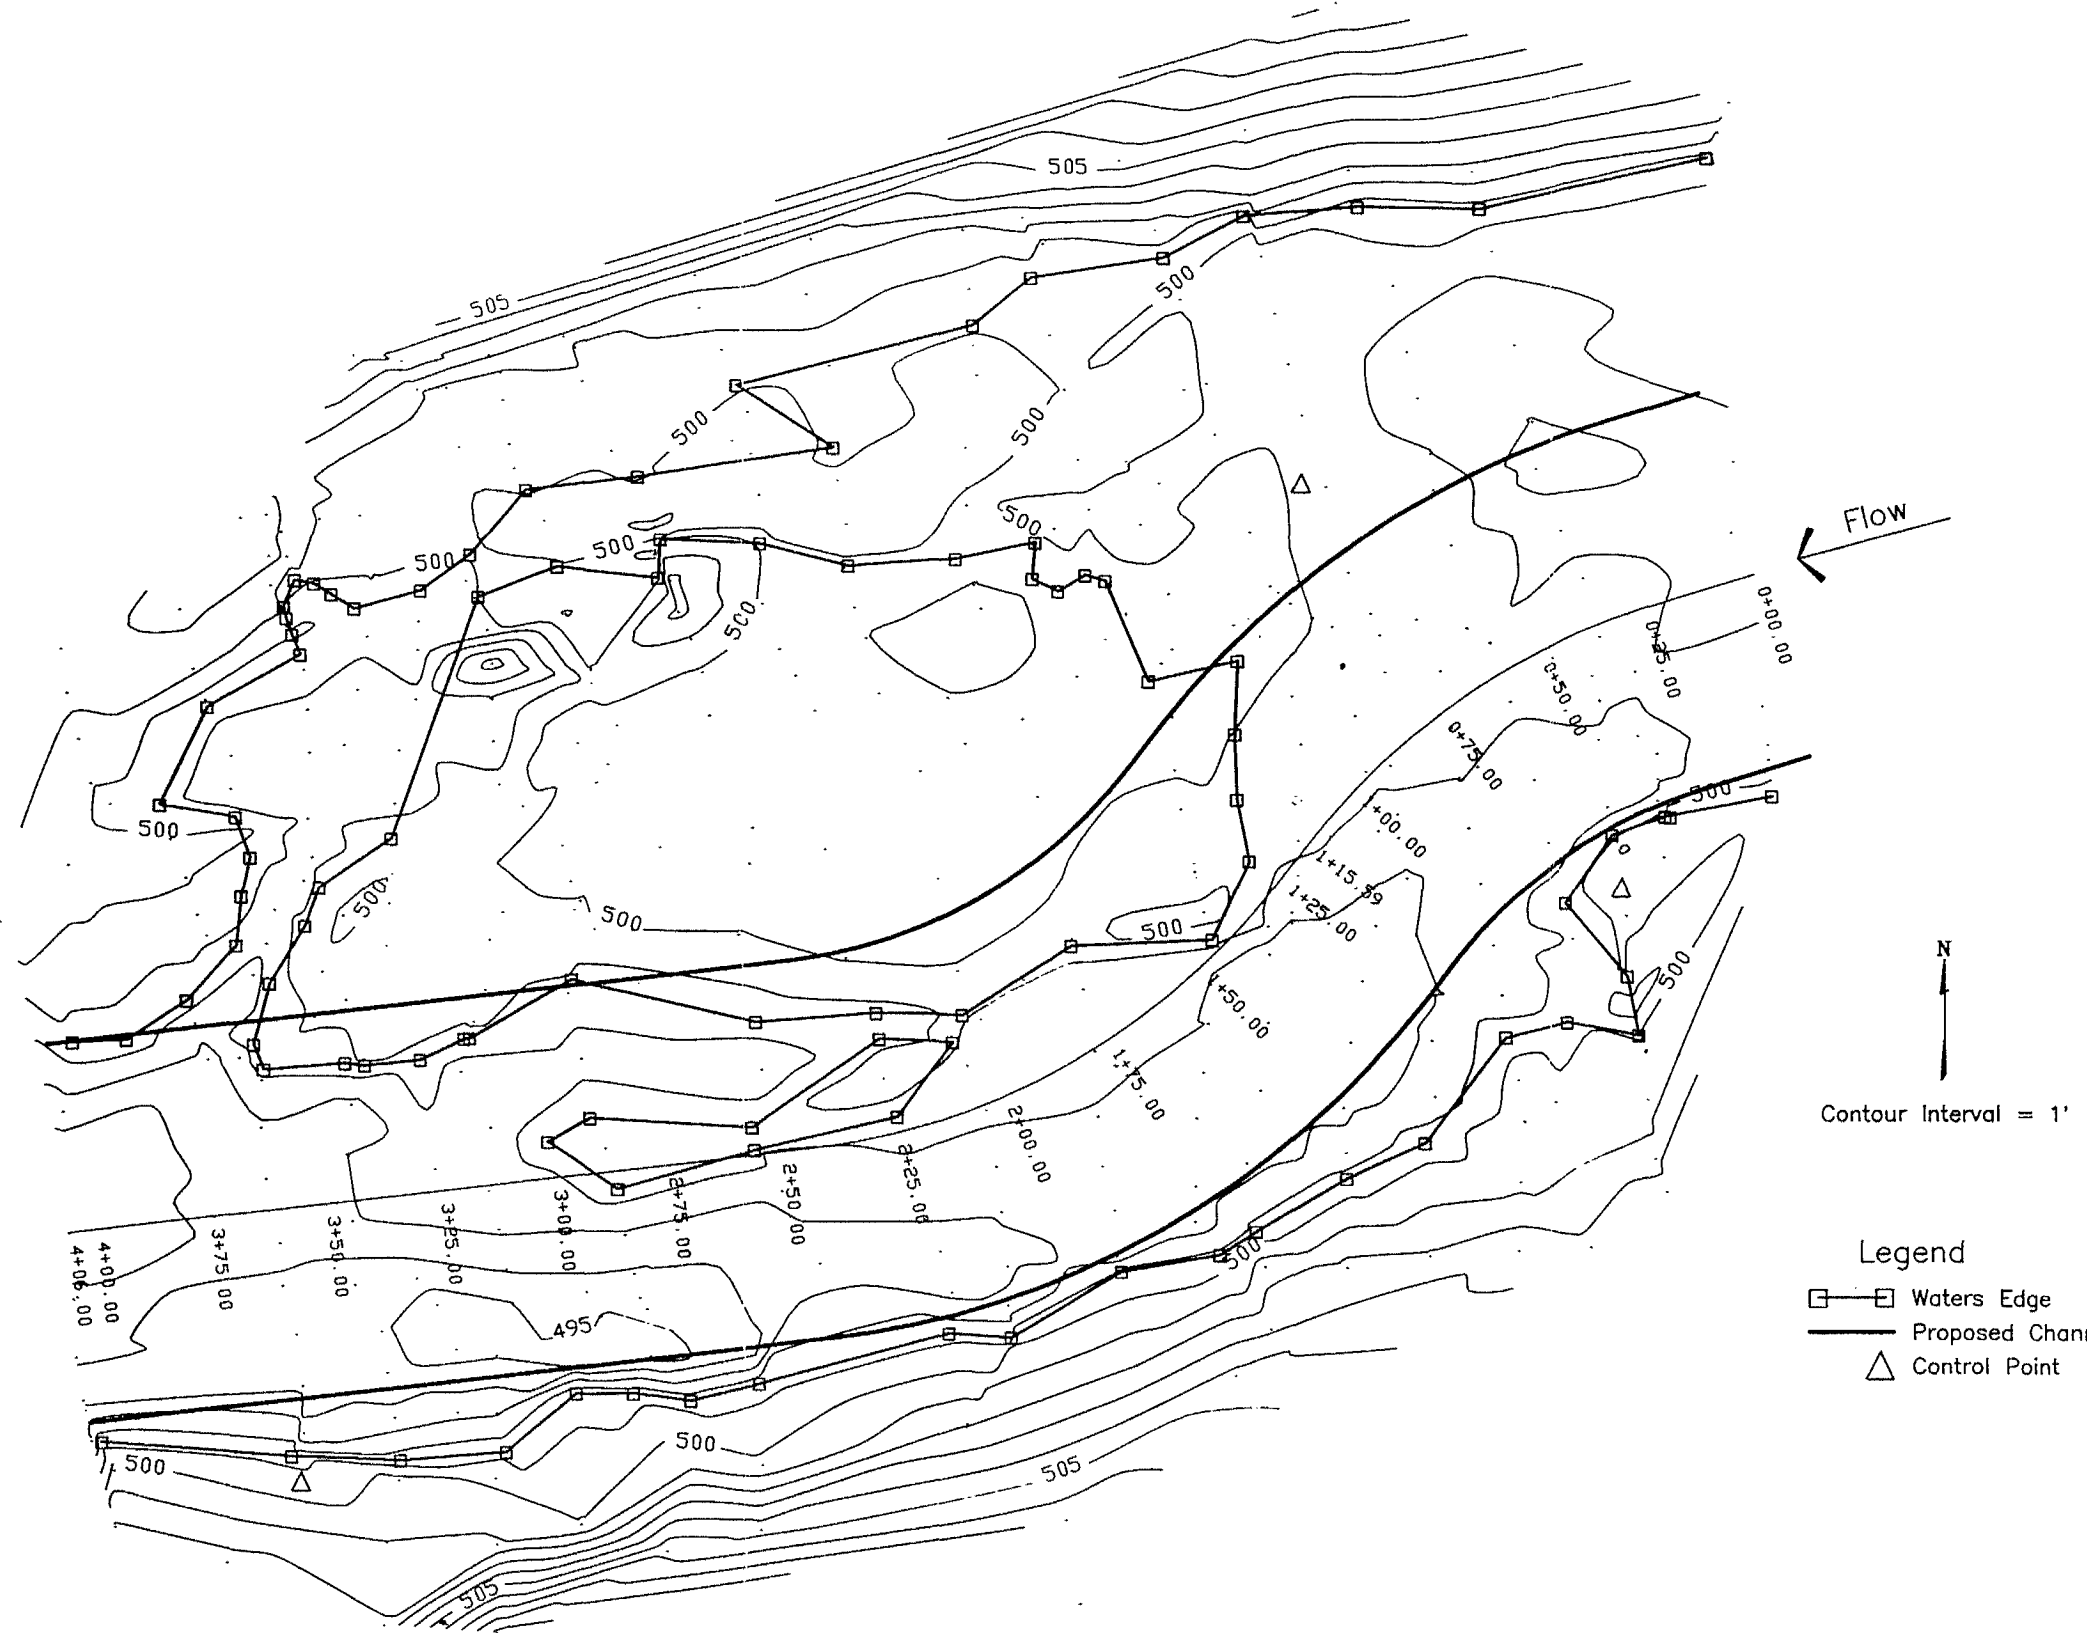
Merced River Riffles 5 & 6, Preliminary Design

| River Mile | Riffle | Approximate Length or Area | Habitat Type | Site Description | Project Description | Rank (B+E)* |
|---|---|---|---|---|---|---|
| 51.4** | 5&6 | 600 feet | Spawning | Tall riparian on both sides. Good backwater area. Great drop and access. | Replace gravel. | 1+1 |

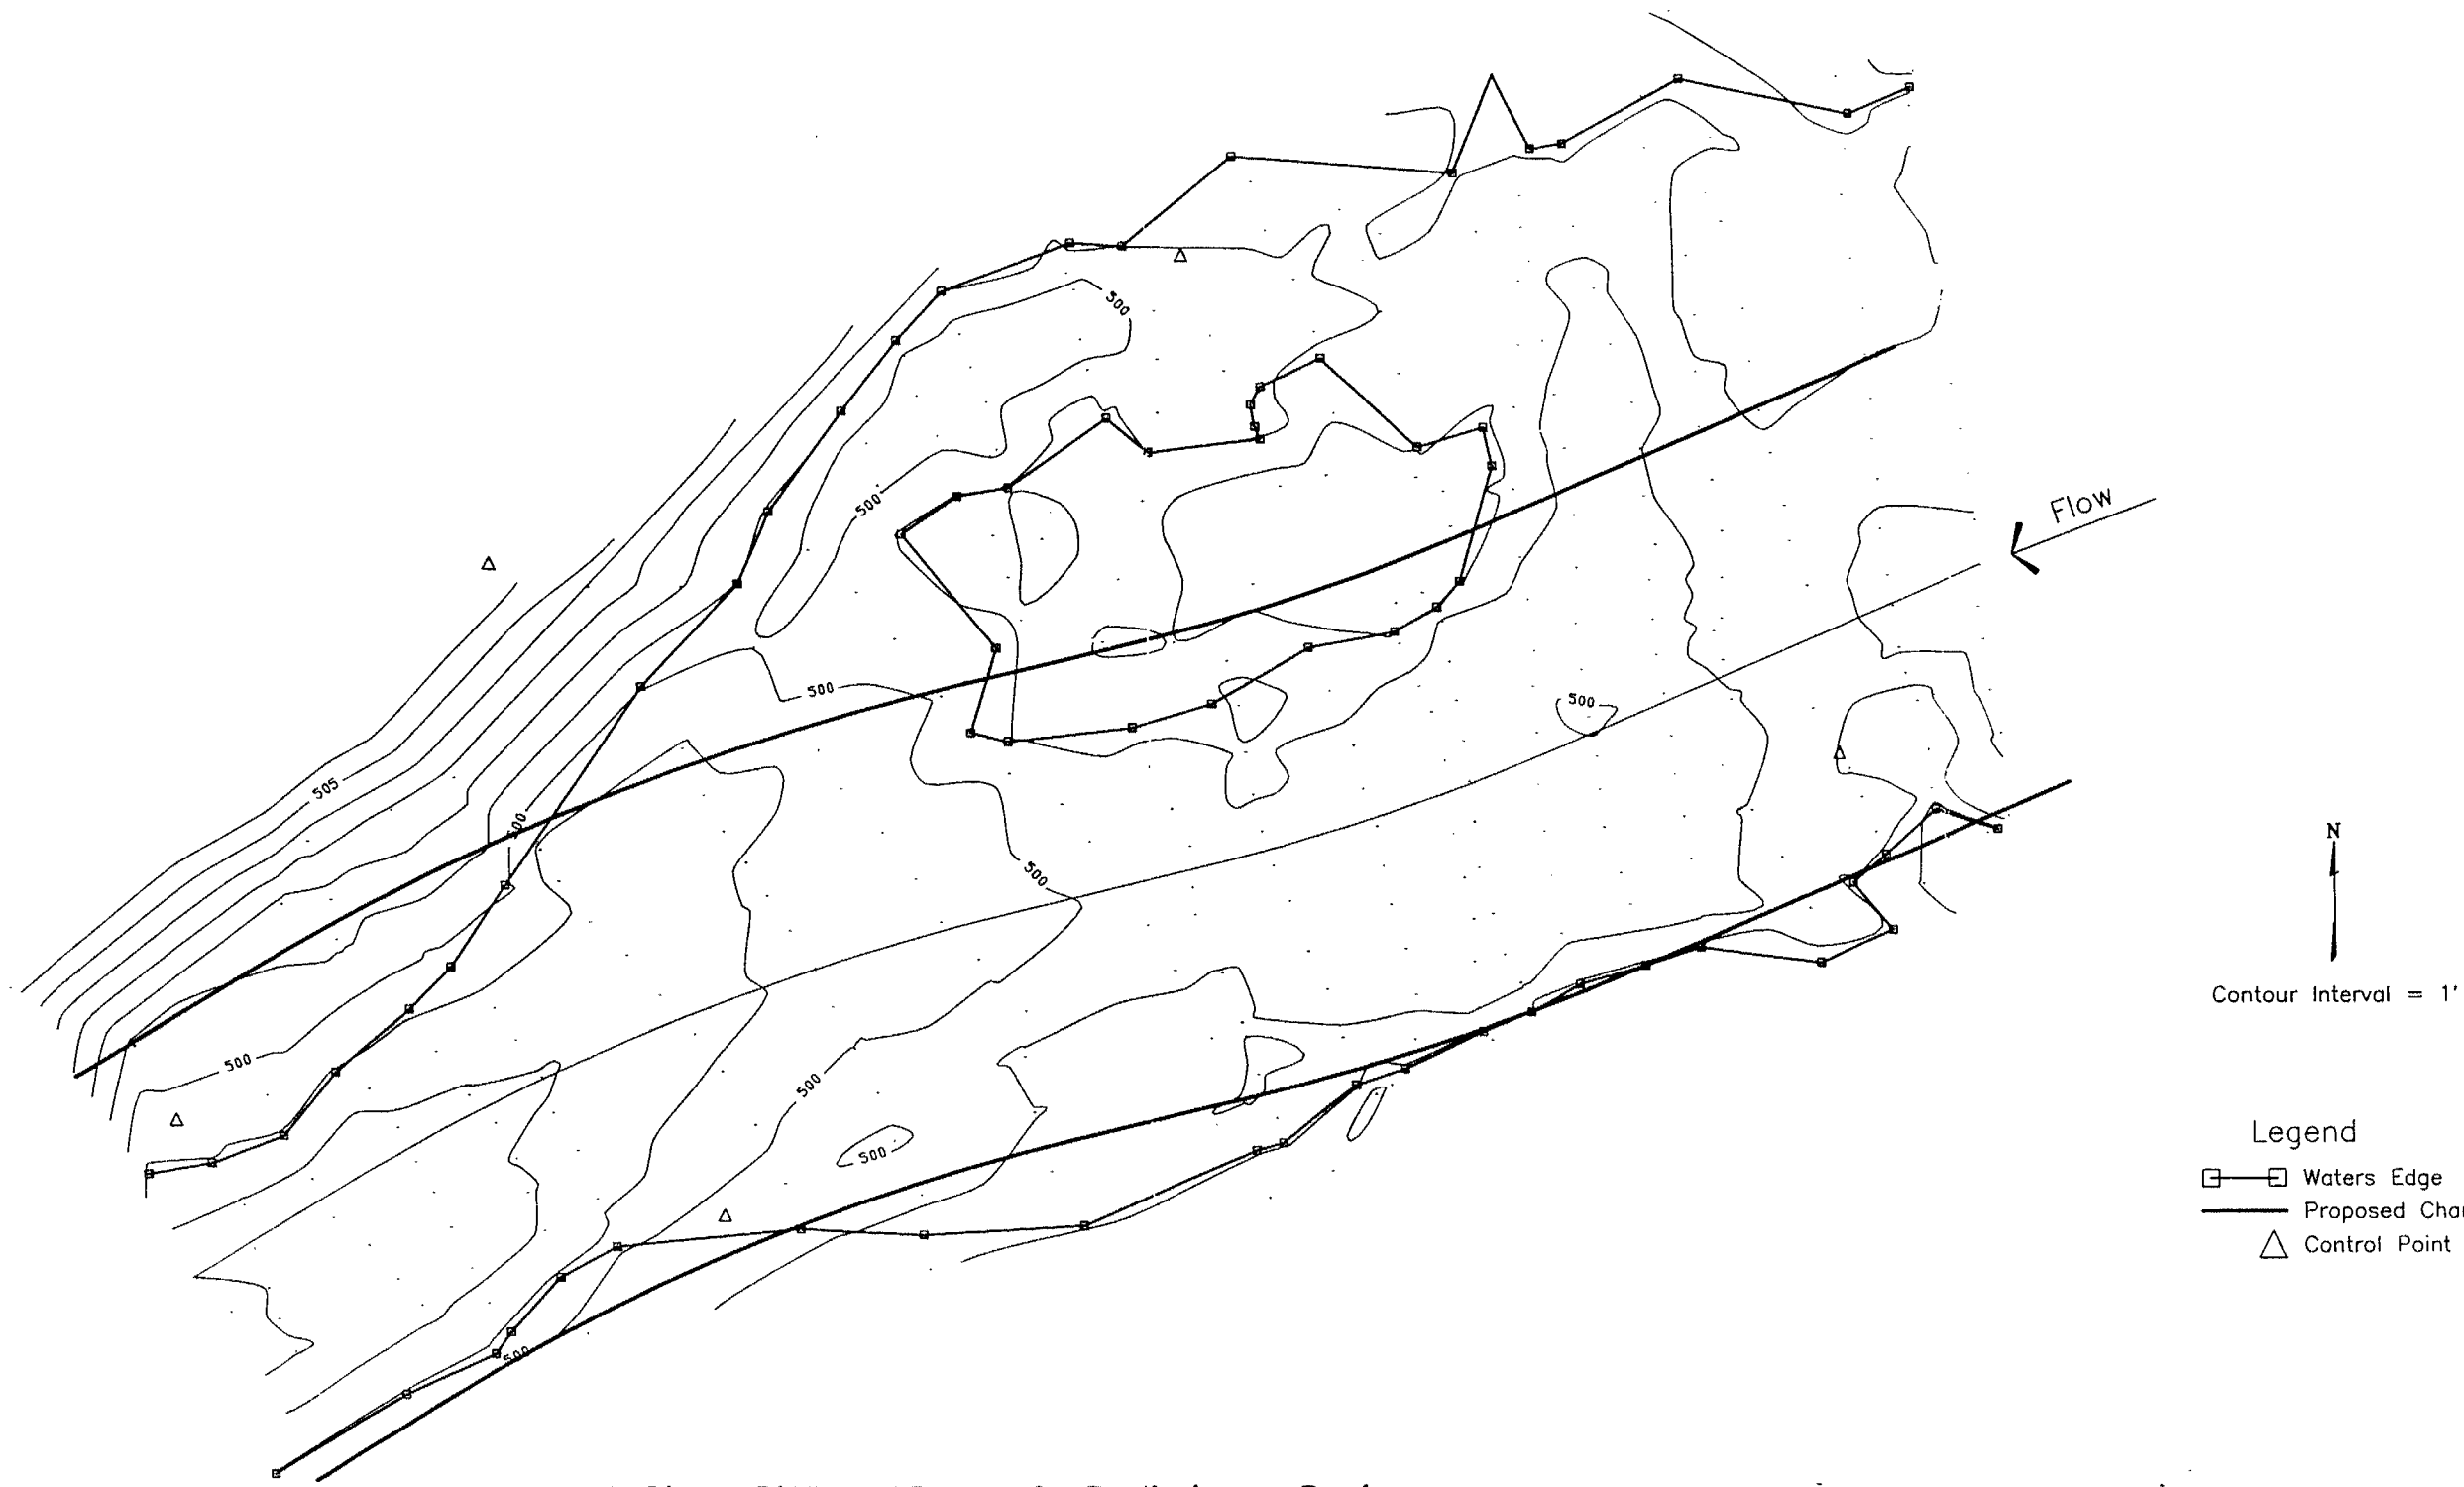
Merced River Riffles 15 & 16, Preliminary Design

| River Mile | Riffle | Approximate Length or Area | Habitat Type | Site Description | Project Description | Rank (B+E)* |
|---|---|---|---|---|---|---|
| 48.4** | 15&16 | 600 feet | Spawning | Great site. 2-to-3-foot drop over length. Great access from north. | Excavate substrate. Replace with spawning gravel. | 1+1 |

Merced River, Mile 48.4, Riffles 15 and 16.  
South channel looking downstream.

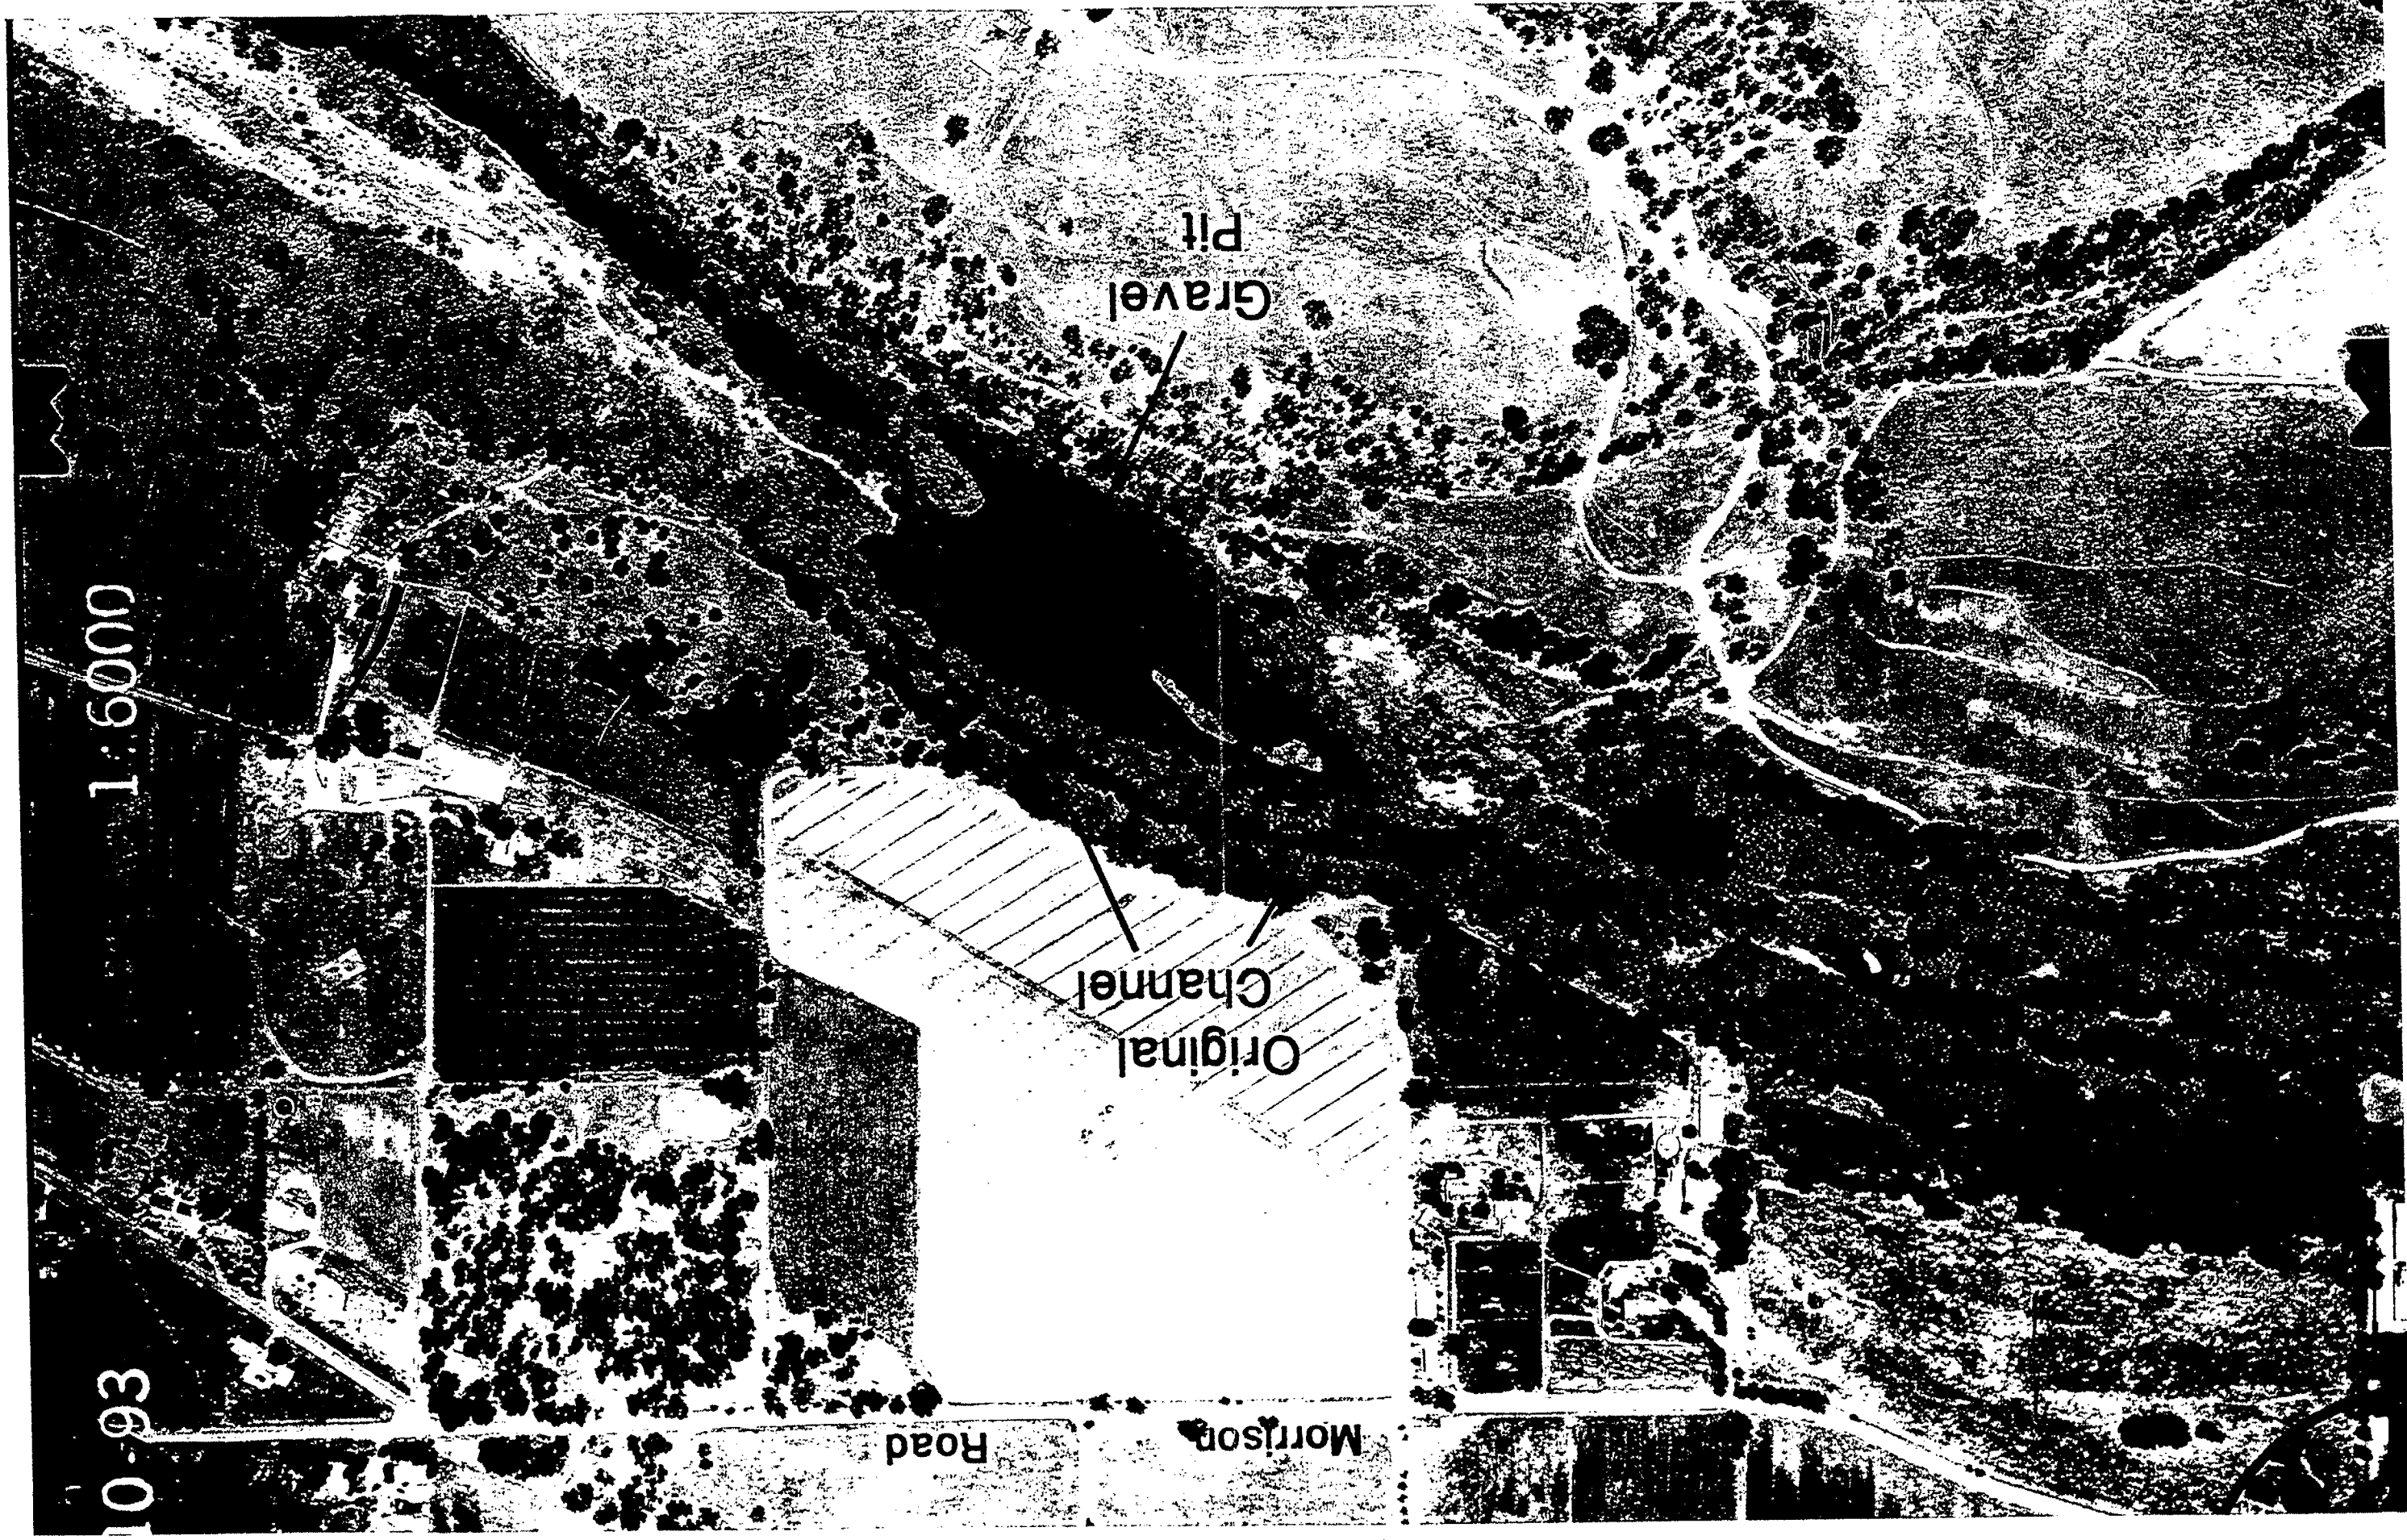
Stanislaus River, Valley Oak Recreation Area and Dillwood Road Site

Poaching could be a problem at this site. It is adjacent to the Corps' Valley Oak Recreation Area, a public use facility.

| River Mile | Site | Approximate Length or Area | Habitat Type | Site Description | Project Description | Rank (B+E)* |
|---|---|---|---|---|---|---|
| 44.7-44.9 | Valley Oak | 600-700 feet | Spawning | Good width, depth, velocity, and access. | Replace gravel. | 1+1 |

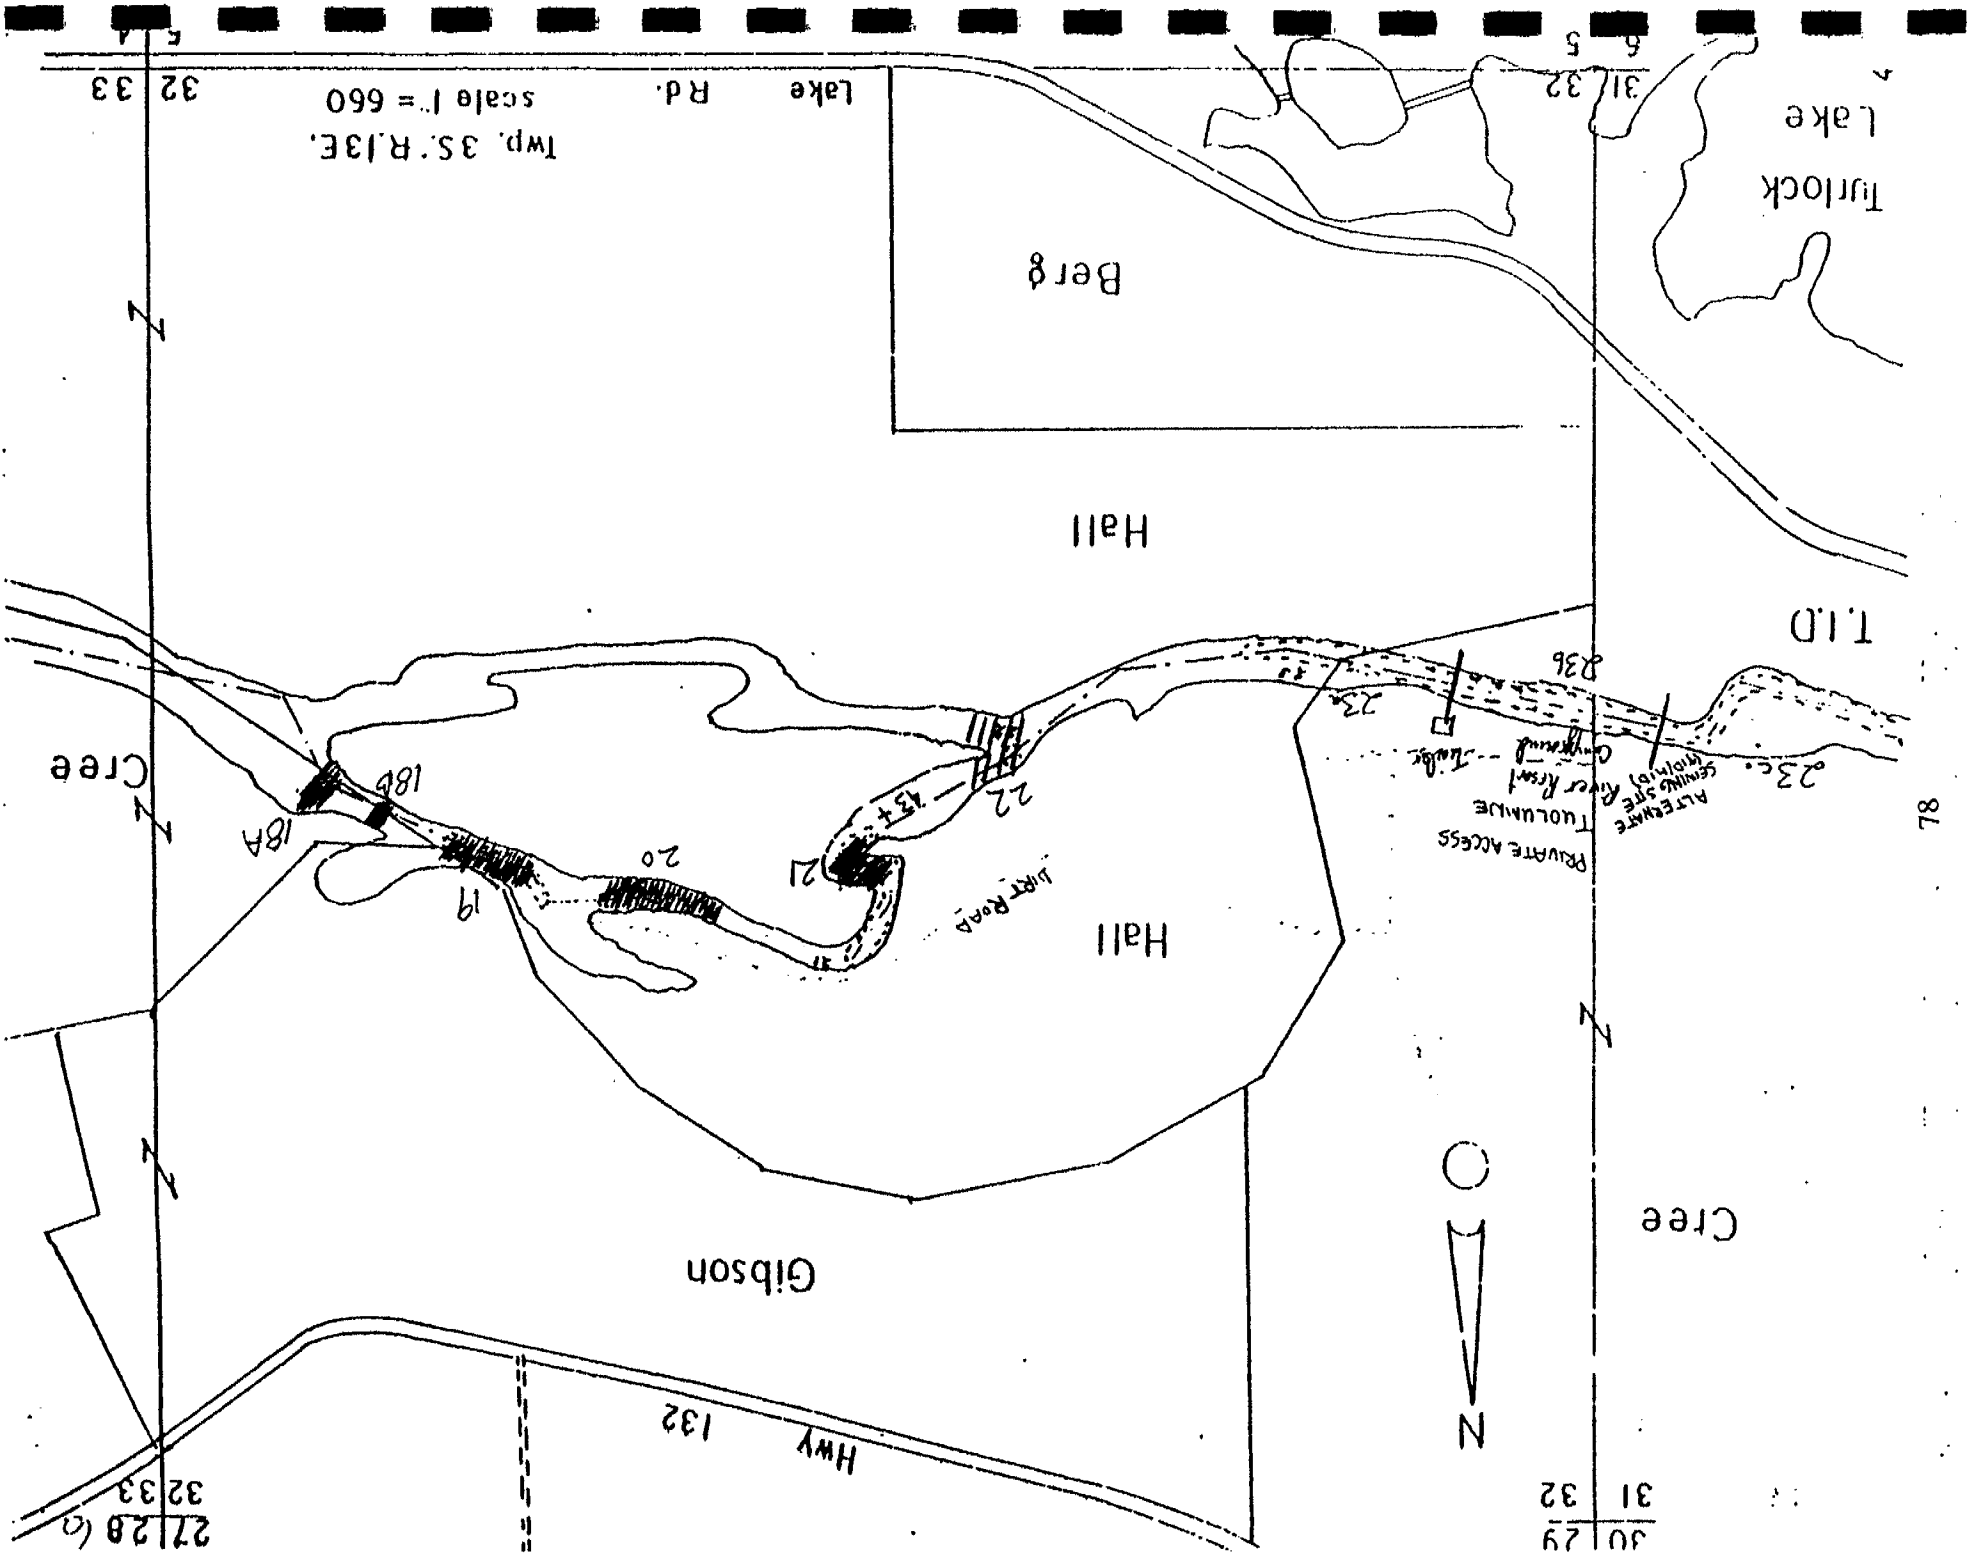
Four riffles exist in a reach of river approximately 1,000 feet long. The river is split at this location and there is significant vegetation encroachment into the channel.

Riffles 19, 20, 21, and 22 could be restored to improve spawning use. Cobble at Riffle 19 could be excavated and replaced with graded, washed spawning gravel. The gravel at Riffles 21 and 22 may only need to be cleaned by ripping. There is good drop over the entire reach and lots of opportunities for creating habitat diversity. The reach is easily accessed off of Highway 132 on the north.

| River Mile | Riffle | Length (feet) | Habitat Type | Site Description | Project Description | Rank (B+E)* |
|---|---|---|---|---|--|---|
| 43.4-43.0 | 19-22 | 700-1,000 | Spawning | Split flow, good diversity. | Replace gravel and remove vegetation. | 1+1 |
